"Sonny" -

Sonny

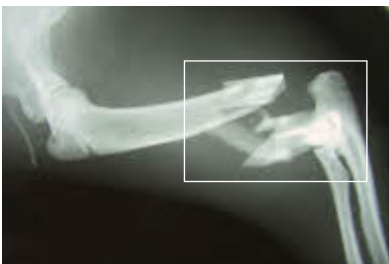
Before

I think that anyone viewing his radiographs will appreciate that "Sonny" had clearly come off worst with his confrontation with a car!

Instead a technique originally pioneered by a Russian doctor (Ilizarov) aimed simply to harness the body's own powers of healing with the minimum of interference. This involves placing stainless steel pins on either side of the injury which are then connected on the outside of the leg with a steel rod (fixator). This surgical procedure then allows the patient to carry on the process of repair and reconstruction with minimal interference.
